T-1000 Ribbon Repair Document

As you may know, the cassette housing of the T-1000 is now manufactured in such a way that opening the housing is not possible. This becomes an issue when a customer needs to repair a torn ribbon. Below are steps for an easy fix to overcome that problem.

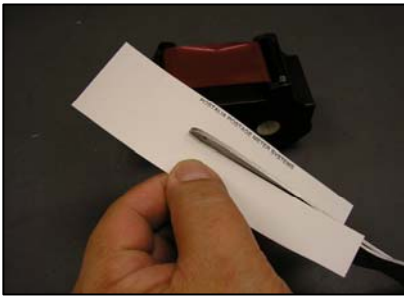
Step 1: Cut a label in half lengthwise.

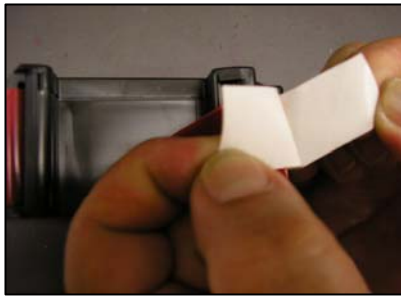
Step 2: Remove about 1/2" of backing paper on one end, exposing the adhesive surface.

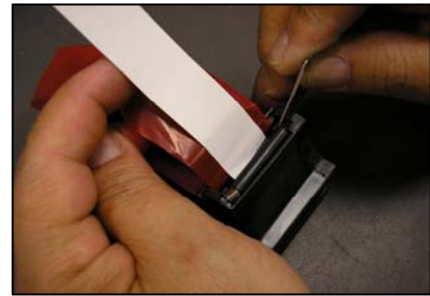
Step 3: Use a paper clip to press open the ribbon brake and insert the label until it sticks to the ribbon.

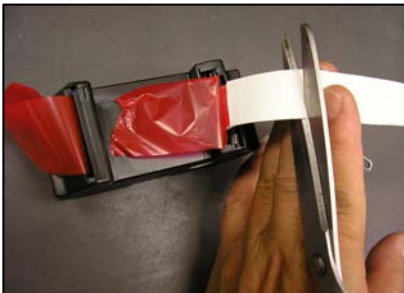
Step 4: Cut the label so that about 2" is remaining outside the cartridge.

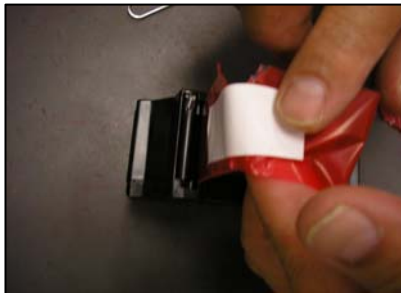
Step 5: Peel off the rest of the backing and attach tape to exposed (other side) ribbon.

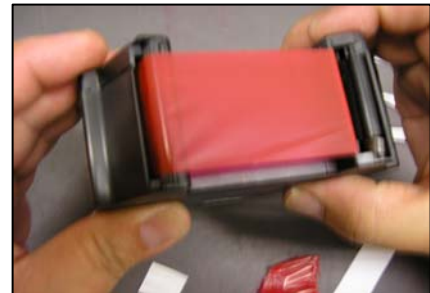
Step 6: Tighten the ribbon using the winding roller until the repaired section of ribbon is fully inside the cartridge.

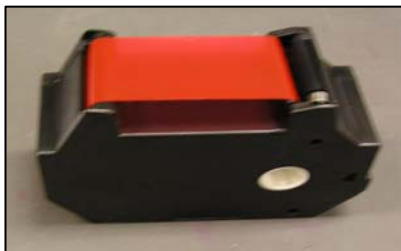
Step 7: The repair should be finished.
